**FINAL REPORT—REMOTE MINE SITE  
DEMONSTRATION PROJECT**

**MINE WASTE TECHNOLOGY PROGRAM  
ACTIVITY III, PROJECT 1**

This document is the final report for the Mine Waste Technology Program (MWTP) Activity III Project 1—Remote Mine Site Demonstration Project. The demonstration was performed at pilot-scale at the Crystal Mine, which is located 7 miles north of Basin, Montana.

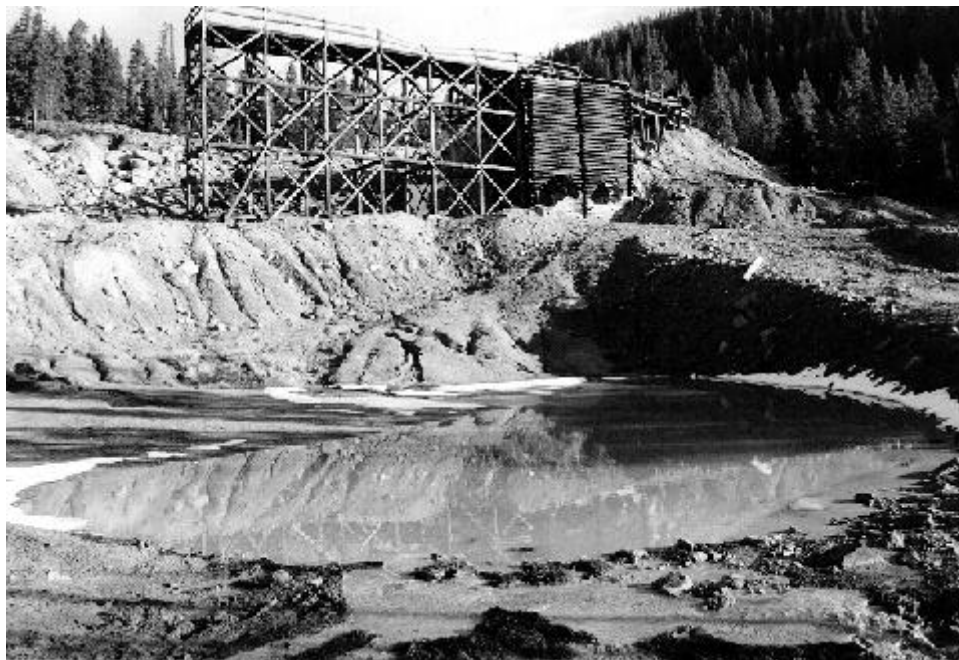
Figure 2-4. Pond and loading trestle.

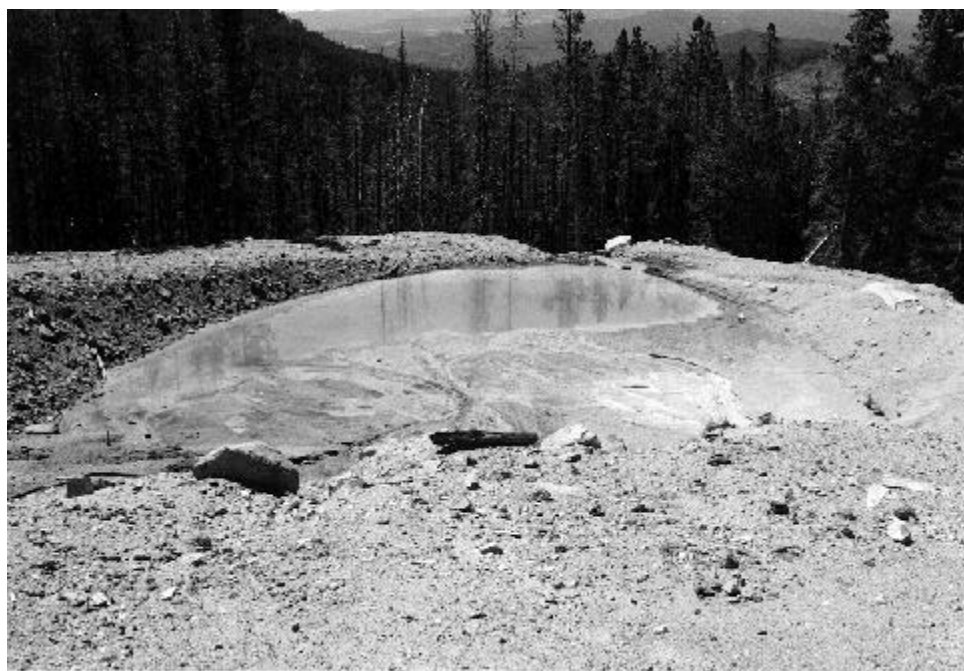
Figure 2-5. Original acidic drainage pond at Crystal Mine site.

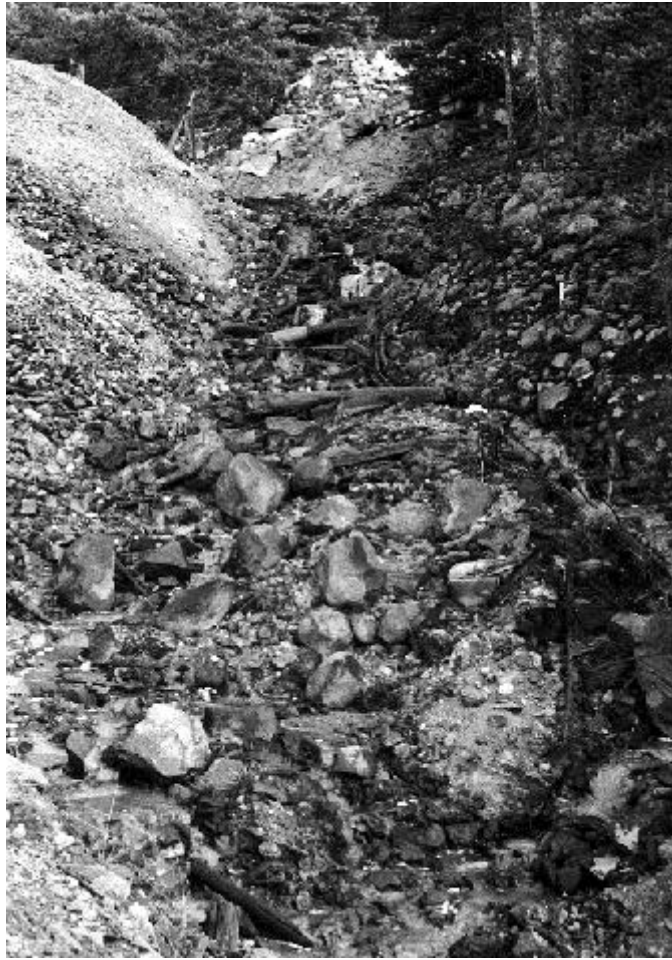
Figure 2-6. Uncle Sam Creek receiving acid drainage.

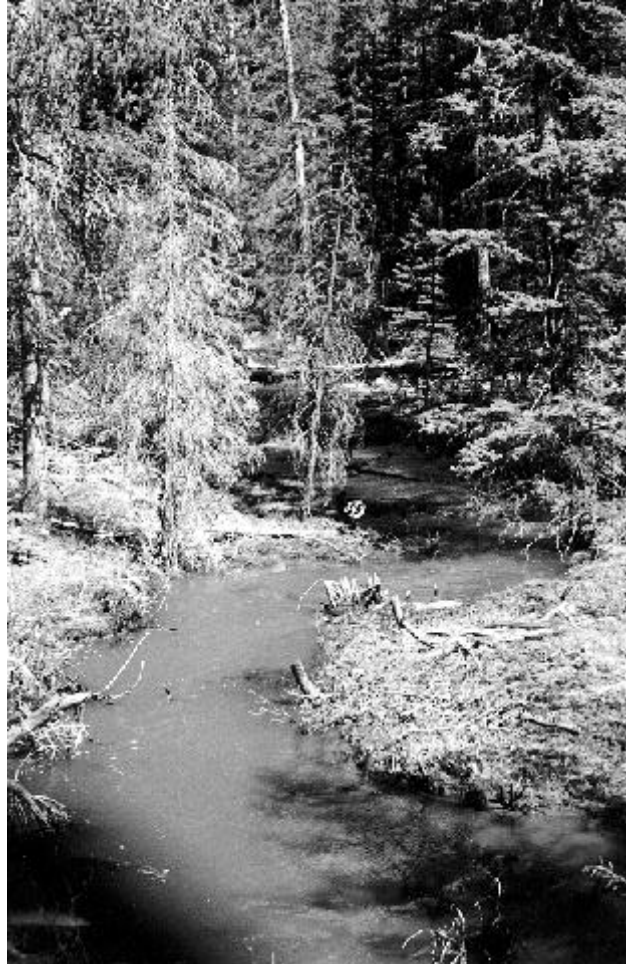
Figure 2-7. Uncle Sam Creek downstream from the Crystal Mine with damage from heavy metals.

Before the demonstration, acidic, metal-laden waters discharged from the lower adit of the Crystal Mine directly into Uncle Sam Creek. This discharge had caused severe damage to this stream and its ability to support aquatic life forms. During the demonstration, water of variable quality discharged from the treatment train. However, the quality of the discharge water was at all times superior to the water that was discharging directly from the mine portal.

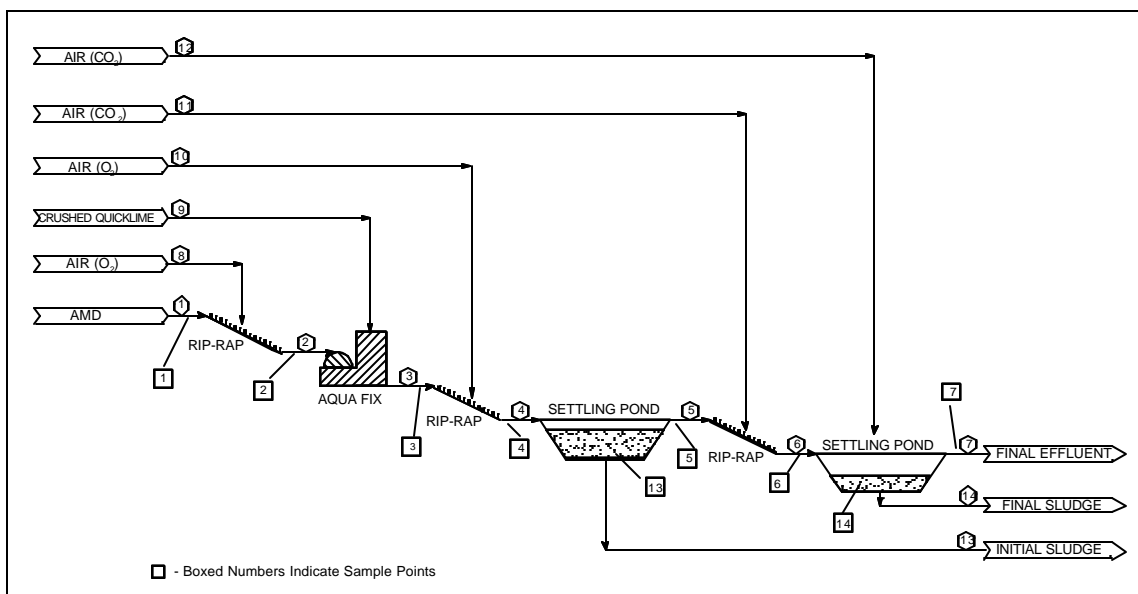
Figure 3-1. Process flow of water sampling sites.

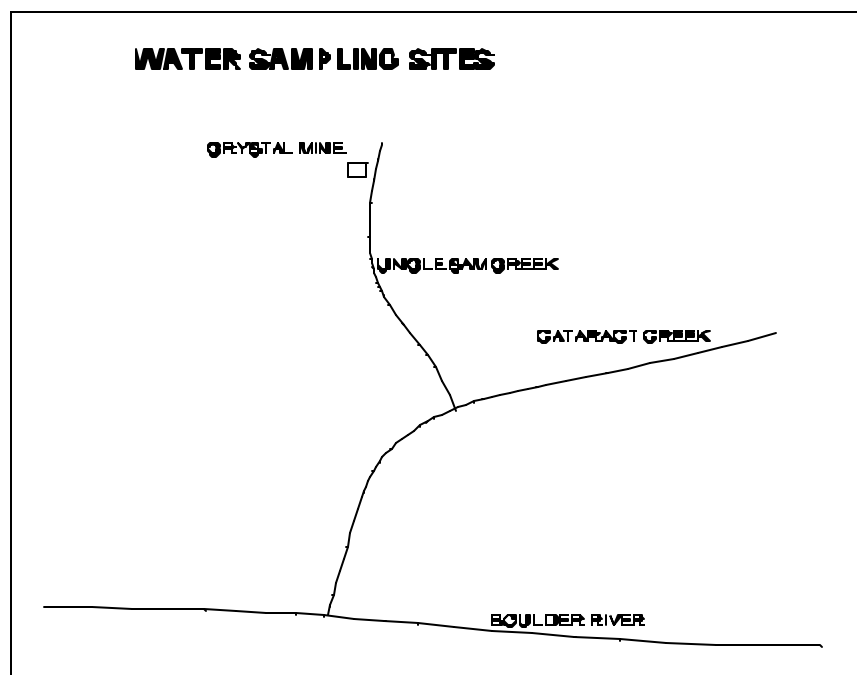
Figure 3-2. Water sampling sites.

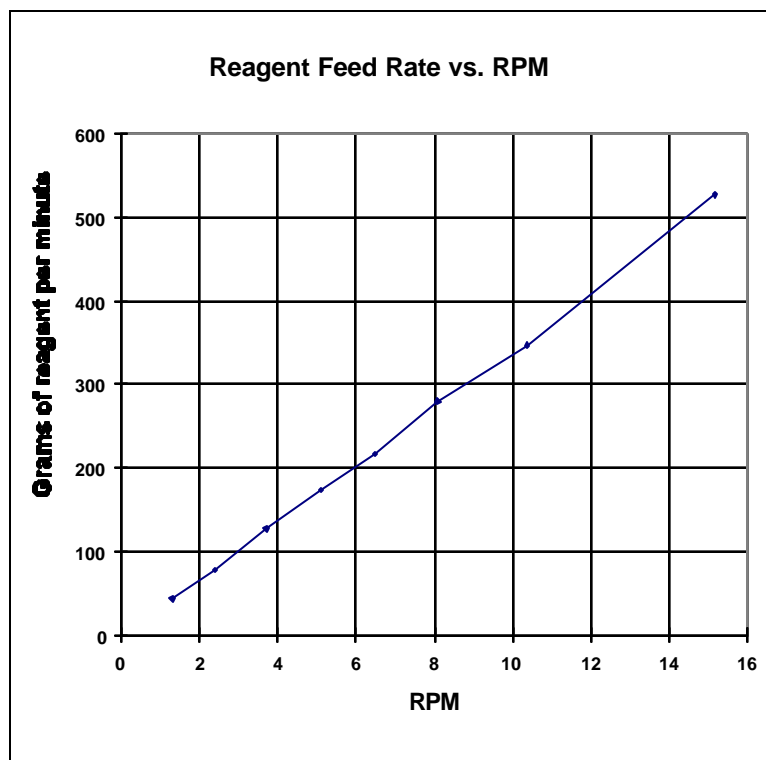
Figure 4-1. Graph A.

Reagent feed rate vs. rpm. (Graph A)

RPM	Feed Rate (grams per minute)
1.3	44.3
2.4	78.6
3.7	127.3
5.1	173.4
6.5	216.8
8.1	279.5
10.4	346.3
15.2	526.7

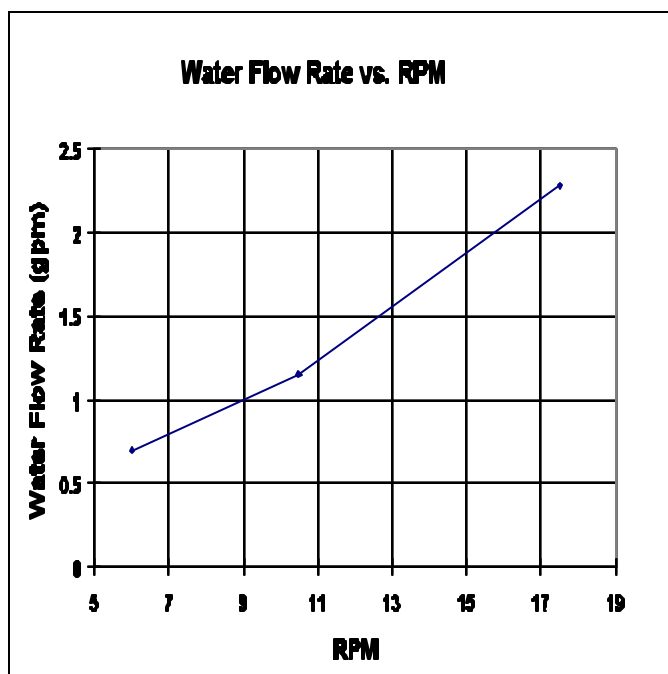
Figure 4-2. Graph B.

Water flow rate vs. rpm. (Graph B)

RPM	Water Flow Rate (gpm)
6	0.7
10.5	1.15
17.5	2.28

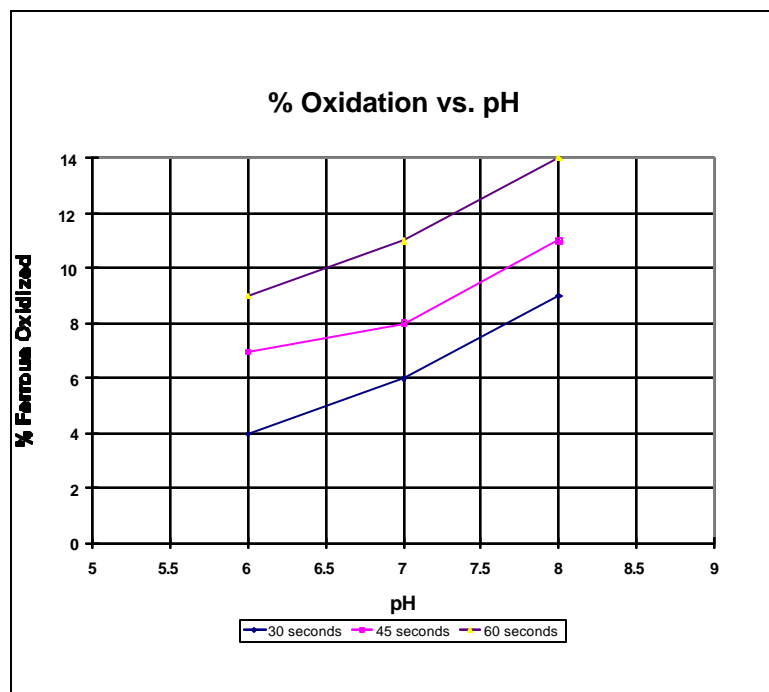
Figure 4-3. Graph C.

% Oxidation vs. pH. (Graph C)

pH	% Ferrous Oxidized		
	30 sec.	45 sec.	60 sec.
6	4	7	9
7	6	8	11
8	9	11	14

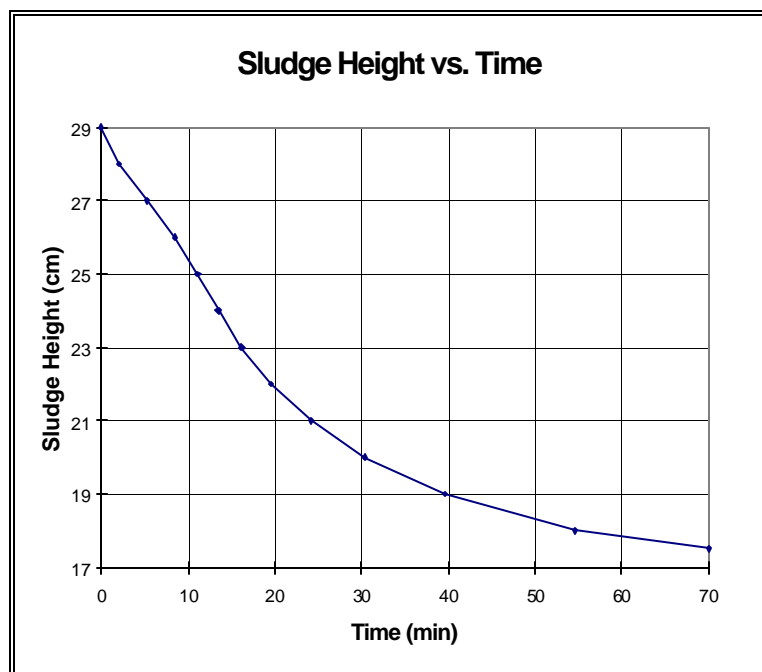
Figure 4-4. Graph D.

Sludge height vs. time. (Graph D)

Sludge Height vs. Time	
Height (cm)	Time (min)
29	0
28	2.03
27	5.25
26	8.42
25	11.13
24	13.47
23	16.15
22	19.42
21	24.12
20	30.28
19	39.63
18	54.67
17.5	70

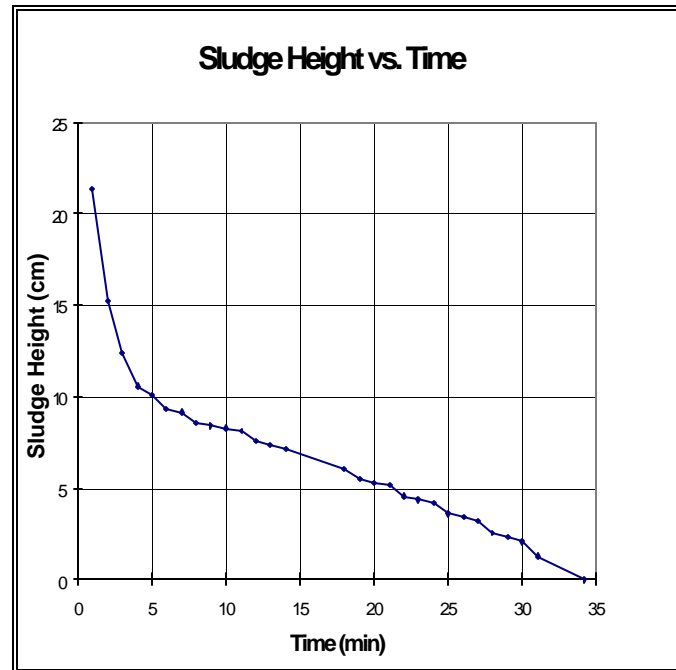
Figure 4-5. Graph E.

Sludge height vs. time. (Graph E)

Sludge Height vs. Time	
Height (cm)	Time (min)
34.2	0
31	1.31
30	2.07
29	2.37
28	2.56
27	3.22
26	3.41
25	3.59
24	4.21
23	4.39
22	4.57
21	5.16
20	5.33
19	5.50
18	6.06
14	7.16
13	7.33
12	7.57
11	8.11
10	8.28
9	8.42
8	8.58

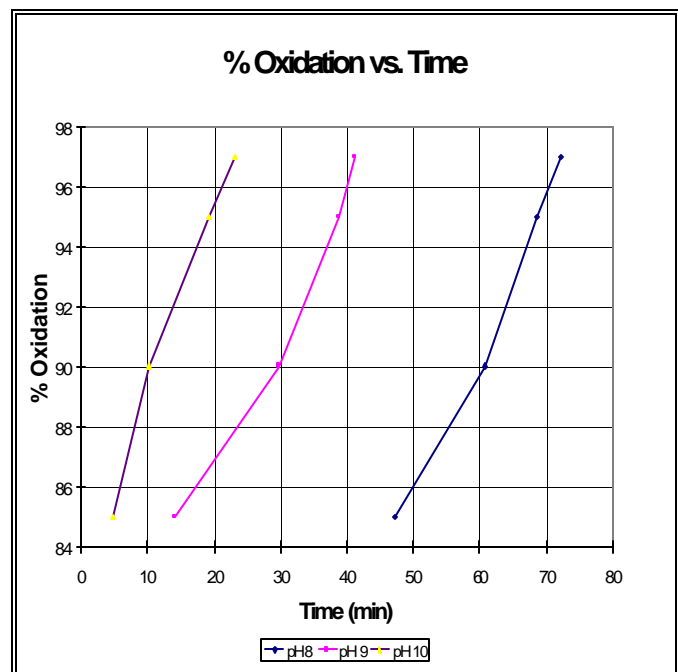
Figure 4-6. Graph F.

% Oxidation vs. time. (Graph F)

% Oxidation vs. Time			
% Oxidized	pH		
	8	9	10
85	47.3	14.1	4.8
90	60.9	29.6	10.1
95	68.5	38.7	19.2
97	72	41.4	23.1

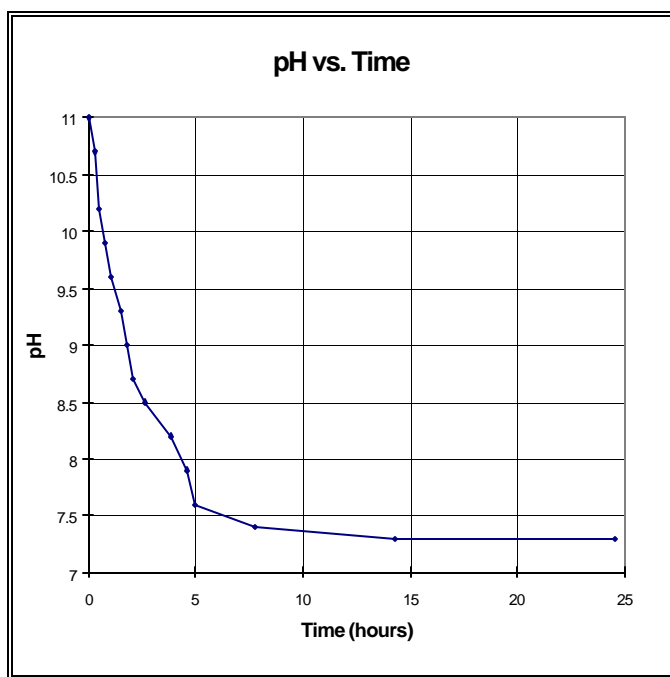
Figure 4-7. Graph G.

pH vs. time. (Graph G)

pH vs. Time	
pH	Time (hours)
11	0
10.7	0.3
10.2	0.5
9.9	0.8
9.6	1.1
9.3	1.5
9	1.8
8.7	2.1
8.5	2.7
8.2	3.9
7.9	4.6
7.6	5
7.4	7.8
7.3	14.3
7.3	24.5

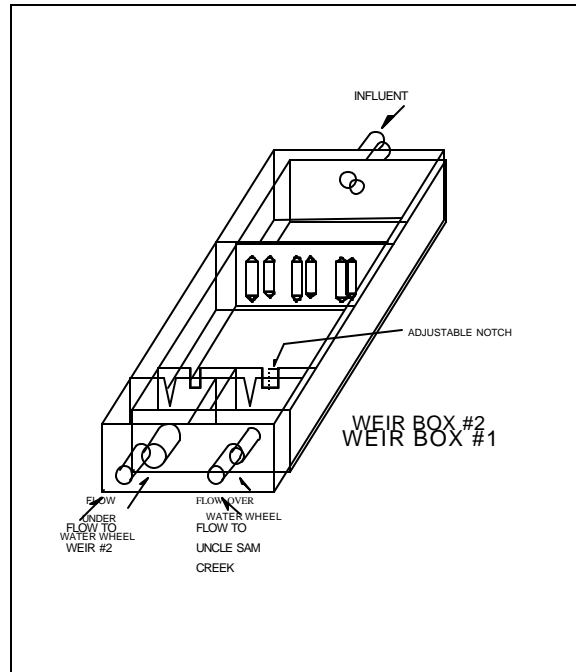
Figure 4-9. Weir #1.

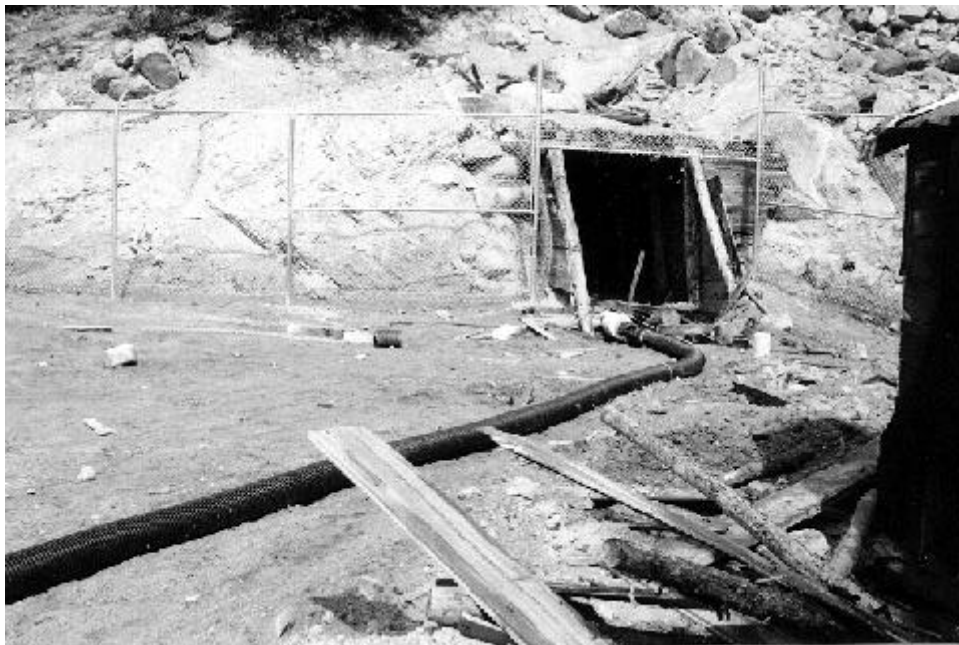
Figure 4-10. Portal and initial oxidation pipe.

This unit operation consisted of a 110-foot length of corrugated polyvinyl chloride (PVC) pipe that was 12 inches in diameter. The turbulent flow of water through the pipe caused air to be entrained into the water. The oxygen in the air then dissolved into the water and partially oxidized the dissolved ferrous iron in the water to ferric iron. The percentages of ferric and ferrous iron dissolved in the water discharging from the lower portal of the Crystal Mine were 85% and 15% respectively. As such, the oxidation required from this operation was minimal. The small amount of oxidation that was required precluded much examination of oxidation methods. However, the oxidation of ferrous iron to ferric iron is slow at low pH. As such, oxidation prior to raising the pH is not recommended. The entrainment of as much dissolved and suspended oxygen into the water prior to raising the pH increases the overall speed of oxidation. A residence time of approximately 30 seconds was used for this unit.

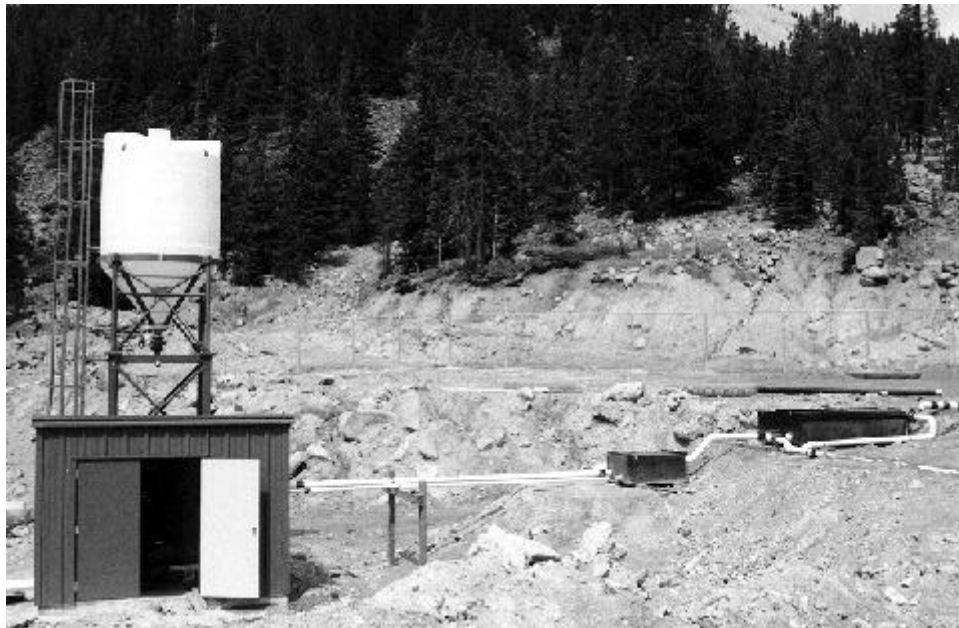
Figure 4-11. AQUA-FIX building and weir boxes at Crystal Mine site.

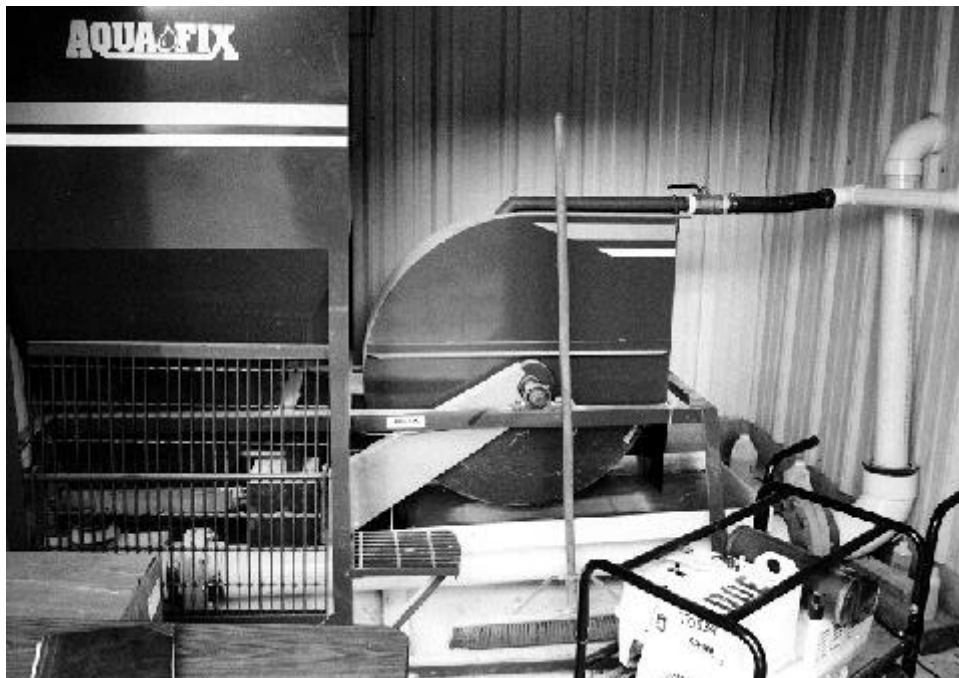
Figure 4-12. AQUA-FIX system.

The AQUA-FIX technology is a water wheel-driven alkaline reagent feeder. Laboratory test work confirmed that by raising the pH of the acidic solution to a value of approximately 10, the concentrations of dissolved toxic metals would reduce to values near or below the boundary conditions applied during this demonstration. The field demonstration showed the technology train is not capable of operating for more than approximately 2 weeks without the assistance of a trained operator to adjust the operation of the process.

Reagent plugging the throat of the AQUA-FIX was caused by a combination of two factors. The first was a function of the design of the AQUA-FIX unit itself. The AQUA-FIX unit was designed with an auger that was shorter than the tube encasing the auger by 6 inches. This caused the reagent to be deposited in a pile within the tube at the end of the auger. This pile would be moved through the tube by the build up of more reagent on the end of the pile. Therefore, the end of the auger encasing tube near the outlet was largely choked with reagent on a constant basis. The second factor that enhanced the clogging of the AQUA-FIX throat was a breeze that moved up the pipeline that conveyed the water from the AQUA-FIX building to the first set of settling ponds. This pipeline has been called the final

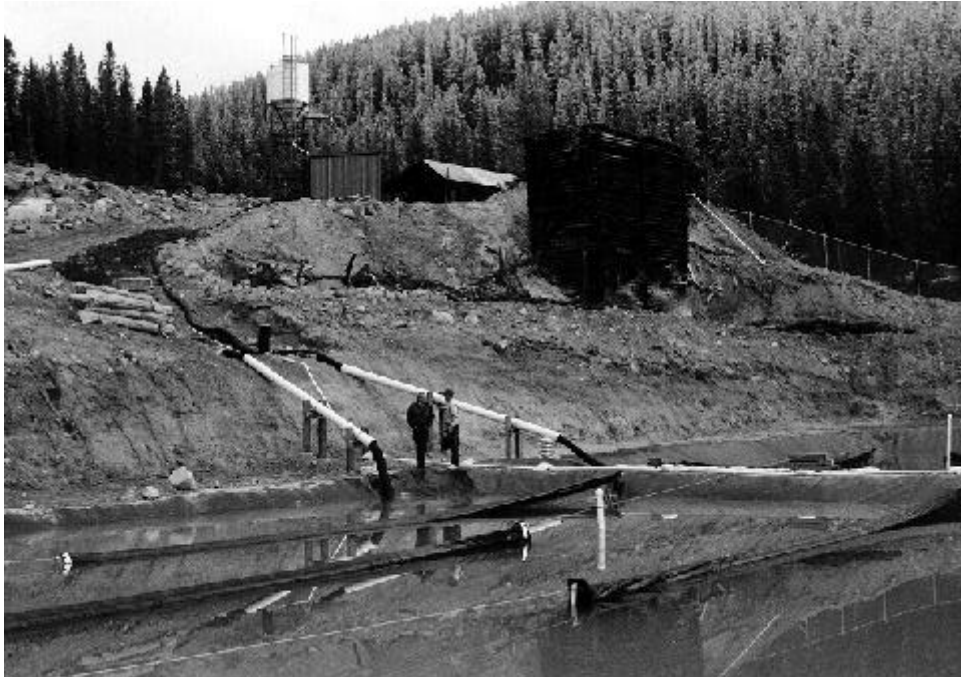
Figure 4-13. AQUA-FIX building with hopper and pipe carry flow to the ponds.

oxidation unit within this document. The pipeline faced downhill to the south and acted like a chimney in that it channeled the breeze into the AQUA-FIX building and the throat of the AQUA-FIX unit. It should be stated that the throat of the AQUA-FIX was less than 2 feet from the beginning of the pipeline in question. The breezes coming into the AQUA-FIX throat helped the reagent to acquire moisture that enhanced the previously described reagent caking. The clogging of reagent within the throat of the AQUA-FIX did not allow reagent to enter the acidic stream. This caused the pH of the effluent to decrease rapidly. To correct the clogging problem, the auger on the AQUA-FIX was lengthened to prevent the reagent from building up within the auger tube. In addition, a cowling was installed that prevented breezes from entering the AQUA-FIX building by means of the final oxidation pipeline.

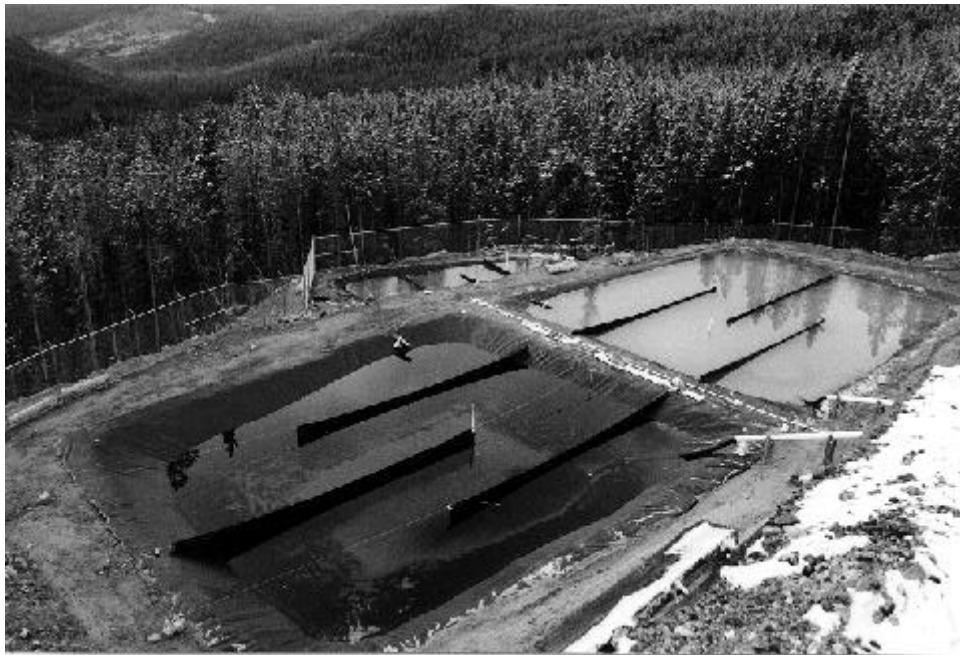
Figure 4-14. Ponds at the Crystal Mine.

The settling ponds with the baffle system installed operated efficiently. The total suspended solids leaving these ponds was less than 10 ppm for 90+% of the operation of the system. The entry point for the treated water into the ponds was at the bottom of each pond. This tended to eliminate problems of the water in the pond freezing and not allowing the water to enter each pond. In addition, this entry point tended to cause the creation of a mound of sludge above the entry point. This mound acted much like a second filter and reaction media for water entering the ponds.

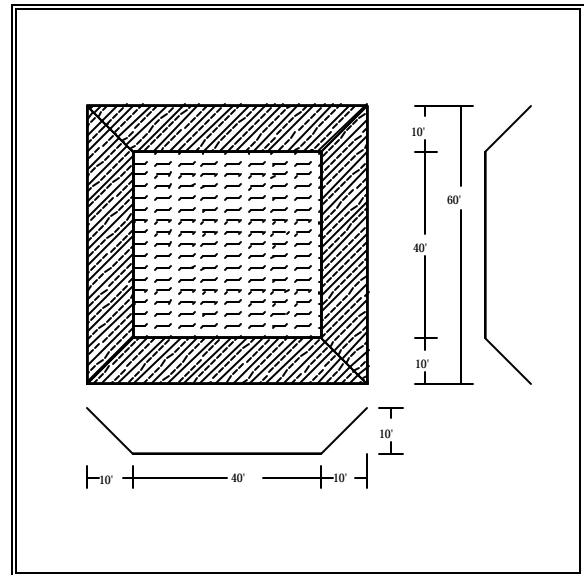
Ponds 1 and 2	
Dimension of the pond bottom	40' × 40'
Bottom surface area	1,600 ft <sup>2</sup>
Dimension of the pond top	60' × 60'
Top surface area	3,600 ft <sup>2</sup>
Pond depth	10'
Pond capacity	25,000 CF 925 CY 187,000 gal

Figure 4-15. Ponds 1 and 2 design.

This unit consisted of corrugated PVC pipe that was 12 inches in diameter. The turbulent flow of water through this apparatus caused air to be entrained in the water. The carbon dioxide in the air then dissolved into the water and reacted with the excess hydroxide produced by the alkaline reagent reducing the pH of the solution. To lower the pH of the effluent solution to a value of 8, a residence time of greater than 5 hours was required (See Figure 4-10) Because of the limited amount of space at the demonstration site, the residence time in the piping was less than 2 minutes. Therefore, a portion of the required residence time was made up in the final pond. Figure 4-14 shows the ponds at the Crystal Mine site. The design for ponds 1 and 2 are shown in Figure 4-15.

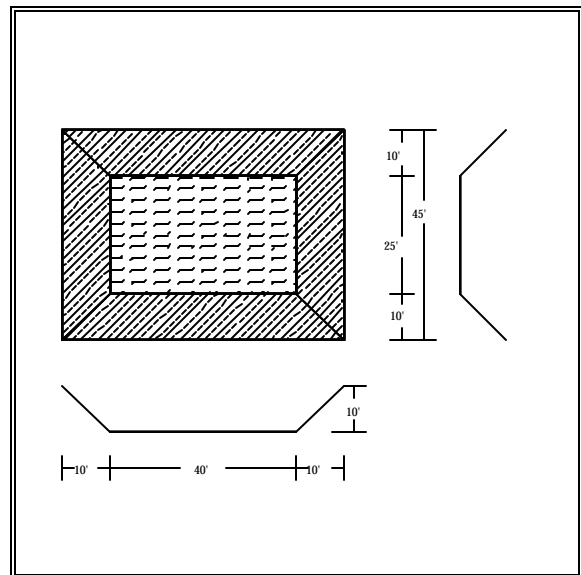
Pond 3	
Dimension of the pond bottom	25' × 40'
Bottom surface area	1,000 ft <sup>2</sup>
Dimension of the pond top	45' × 60'
Top surface area	2,700 ft <sup>2</sup>
Pond side slope	1:1
Pond depth	10'
Pond capacity	17,500 CF 650 CY 131,000 gal

Figure 4-16. Final pond 3 design.

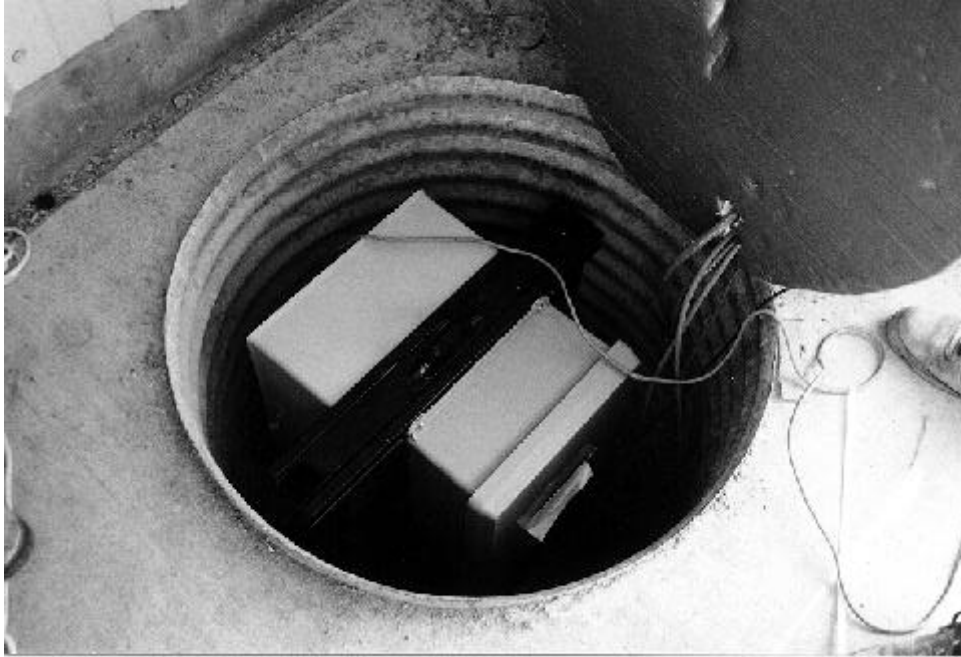
Figure 5-2. Computer data logger and probes.

Flow rate, water wheel revolutions per minute (rpm), pH, oxidation-reduction potential ( $E_H$ ), and temperature were measured on a semi-continuous basis at several points. These measurements were accomplished by placing probes in the flow that transmitted data on a half-hour basis to a data logger. This data was downloaded daily by way of a cellular network and modem. Most of the probes failed within 30 days; therefore, the rpm was the only data that continued to be transmitted throughout the project duration. This data proved valuable throughout the project to distinguish when problems occurred with the reagent feed mechanism. Figure 5-1 shows the probes, and Figure 5-2 shows the computer data logger with the probes.

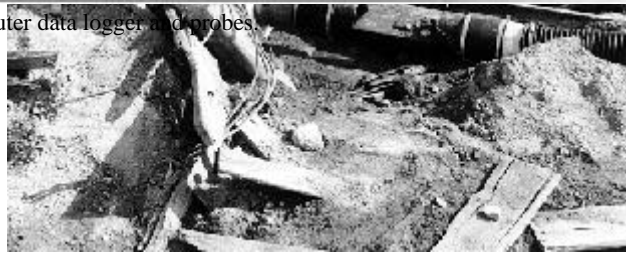
Figure 5-1. Data probes within sections of the tube.

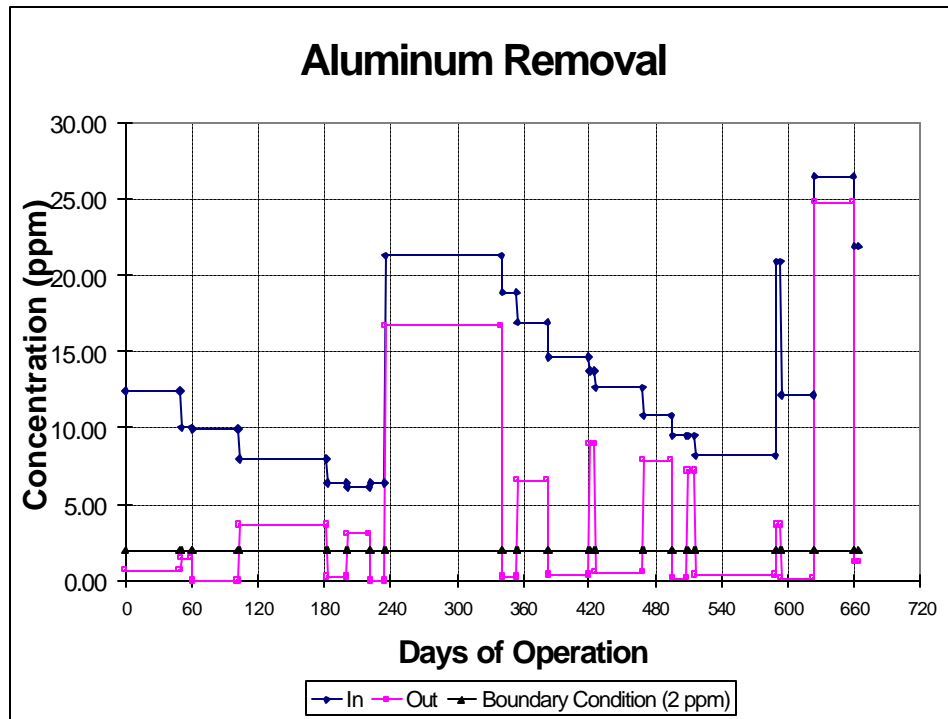
Figure 7-1. Aluminum removal.

Table 7-1 gives the dissolved chemistry field data, and graphically displays the results of the treatment technology train for each of the eight elements observed throughout the demonstration. These eight elements are: Al, As, Cd, Cu, Fe, Pb, Mn, and Zn. Contained in these figures is the mine adit effluent concentration (influent), the treatment train effluent concentration (effluent), and the boundary condition for each element.

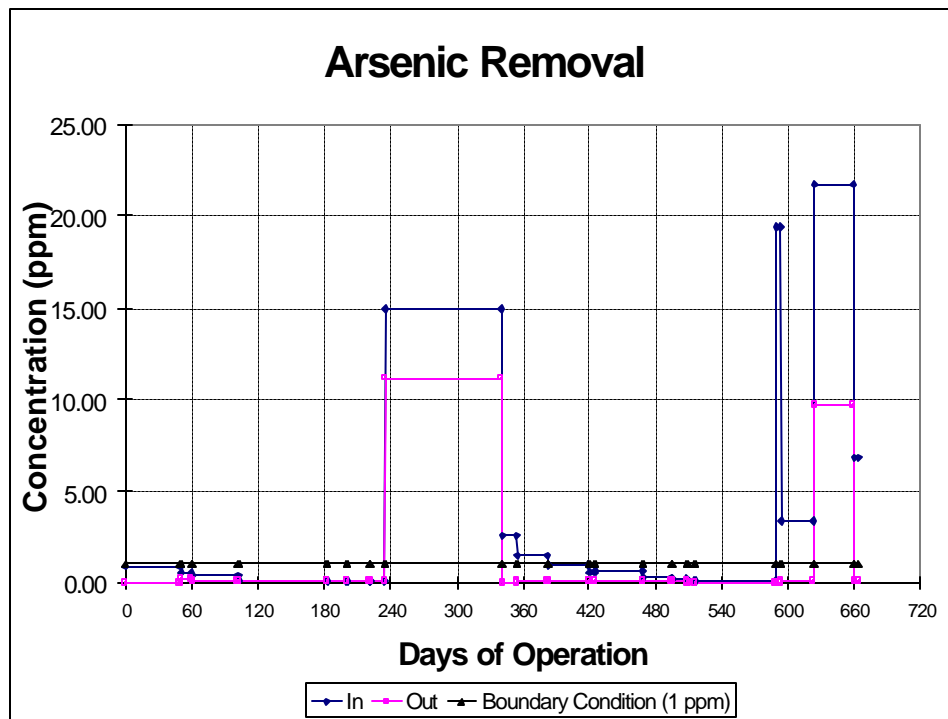
Figure 7-2. Arsenic removal.

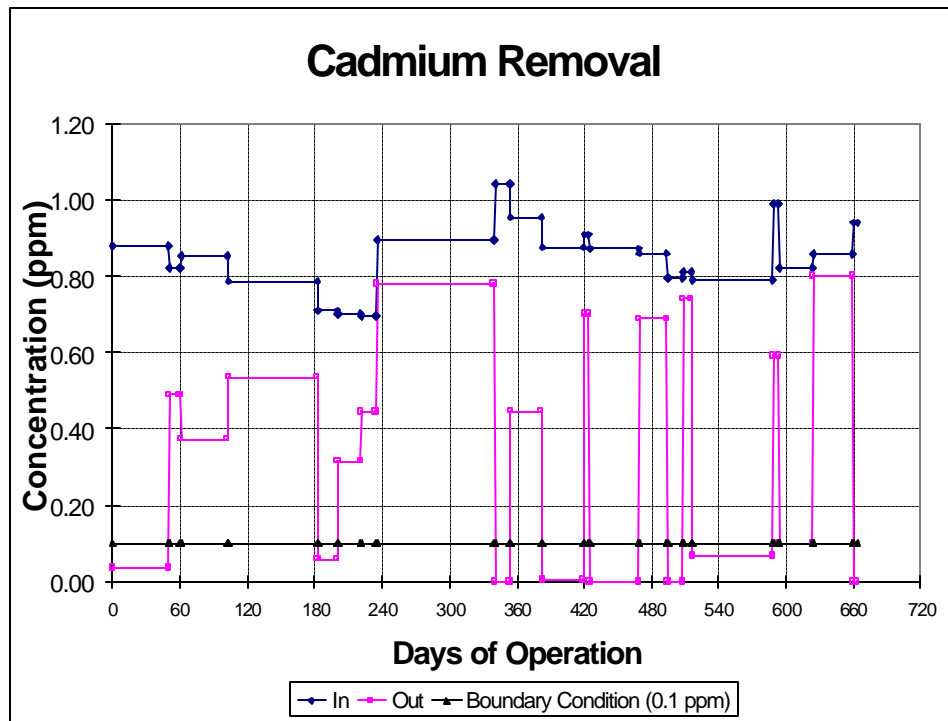
Figure 7-3. Cadmium removal.

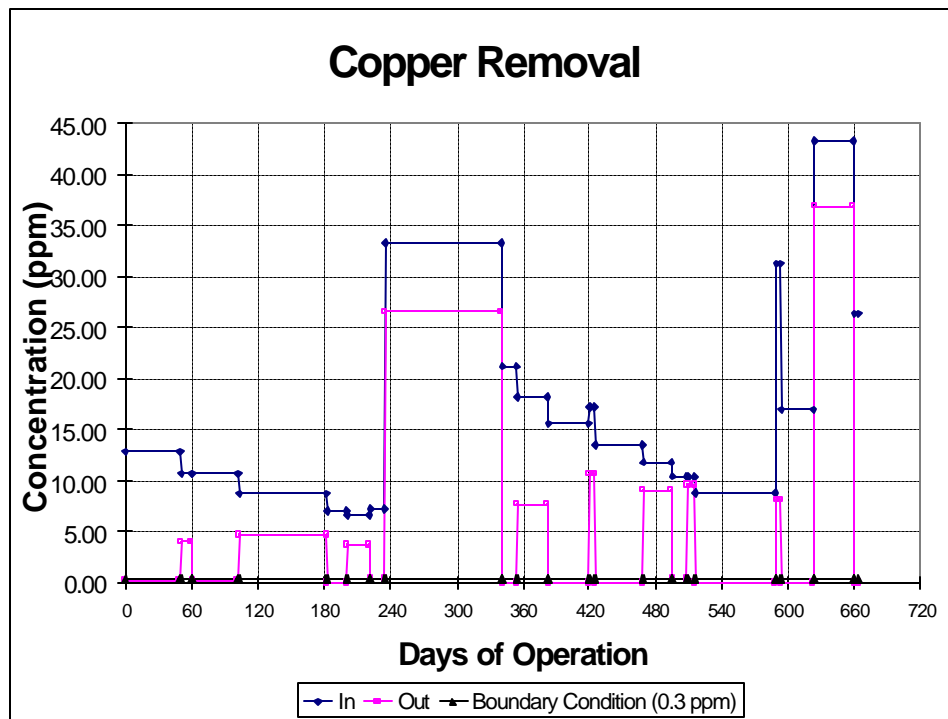
Figure 7-4. Copper removal.

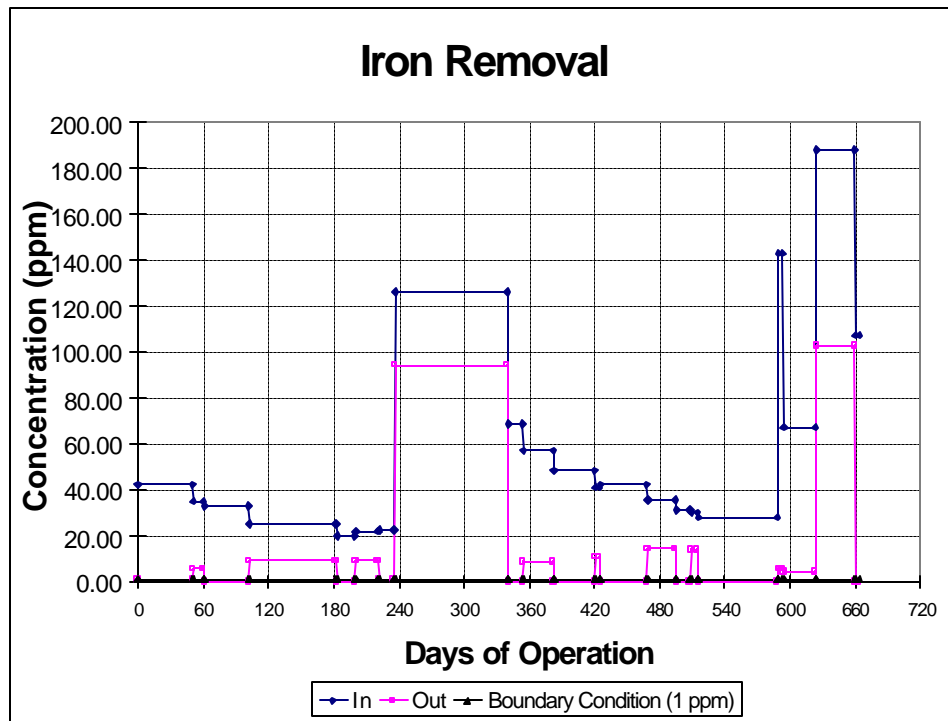
Figure 7-5. Iron removal.

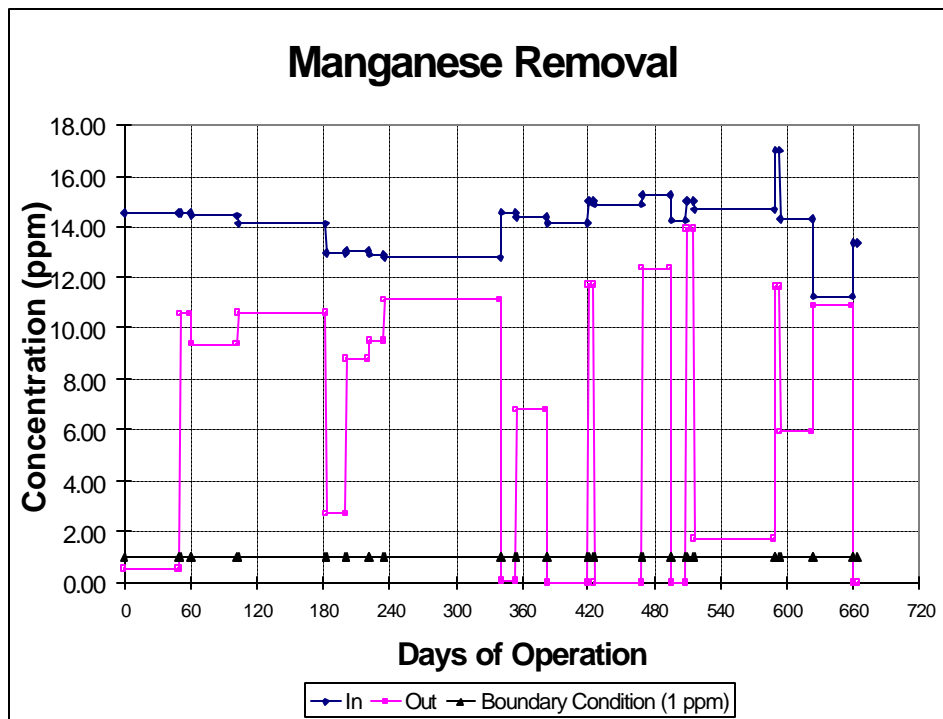
Figure 7-6. Manganese removal.

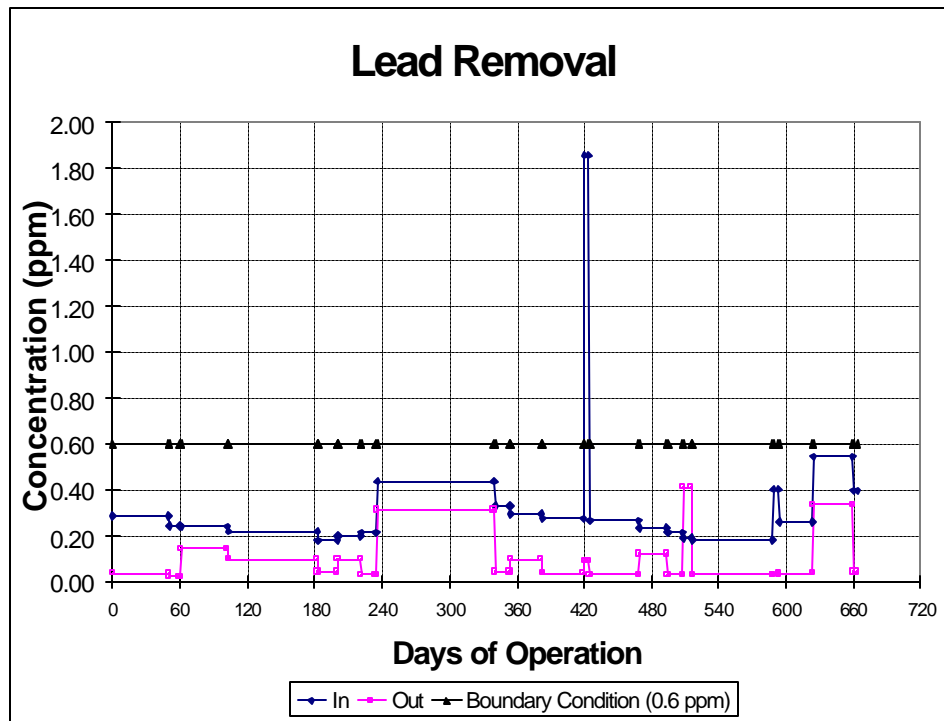
Figure 7-7. Lead removal.

The concentration of Pb being discharged by the system met the boundary conditions 99% of the time. However, the concentration of Pb within the Crystal Mine drainage is extremely low and was lower than the boundary conditions for large periods during the demonstration.

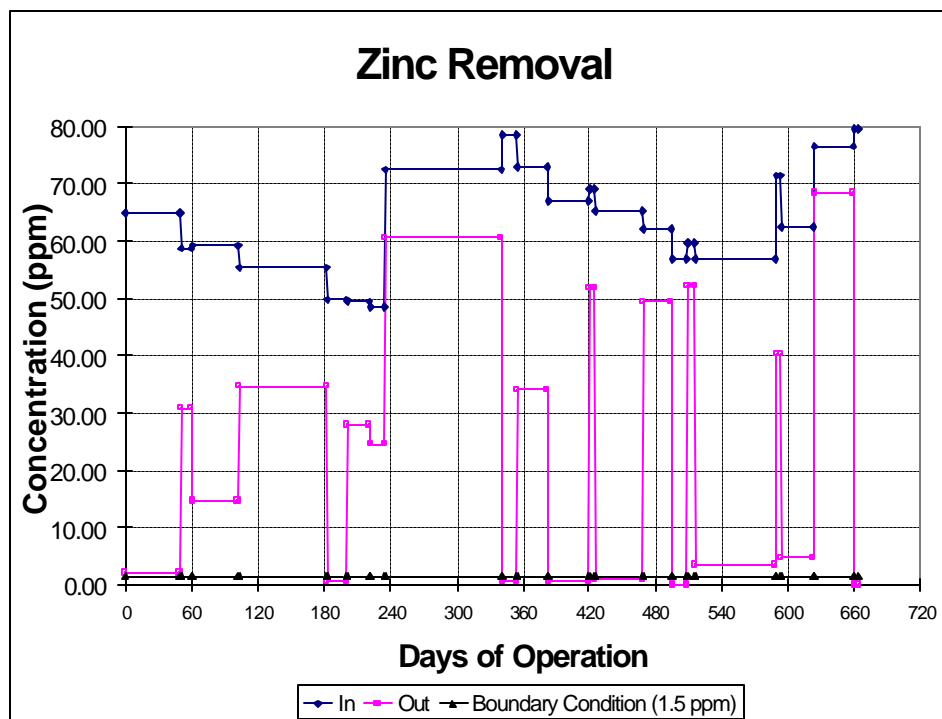
Figure 7-8. Zinc removal.

The concentration of Zn being discharged by the system met the boundary conditions only 44% of

the time. This was largely because the pH of the treated water must reach a value near 10 to successfully remove Zn to the level of the boundary conditions. This value of pH was only reached 44% of the time during operation.
